Investigation report

Leakage testing of coal seam gas wells in the Tara
'rural residential estates' vicinity

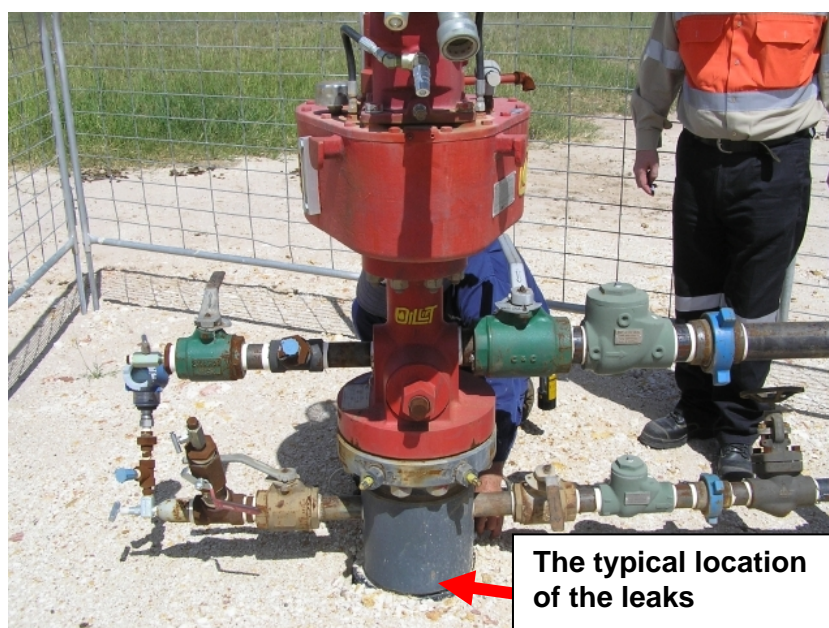
Photo of a typical well head – majority of the detected gas readings were recorded at the threaded connection between the steel casing pipe and the well head base at ground level (see red arrow).
